We have verified the interconnectivity between Juniper EX4200 and ALAXALA products (AX series).

Doc. No. NTS-09-R-045

2010.2.26

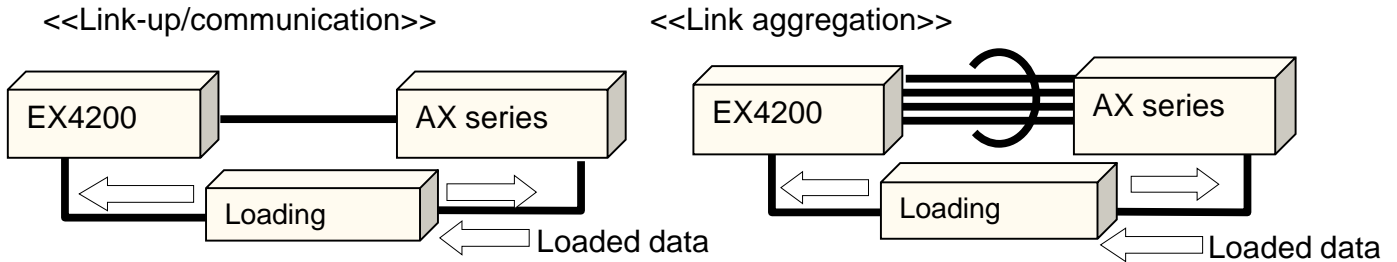
1. Evaluation on link-up/communication and link aggregation

Interfaces used for evaluation

UTP: Auto Nego(10/100TX), Auto Nego(10/100/1000T), 10BASE-T(fixed), 100BASE-TX(fixed), 1000BASE-T(fixed)

Link-up/communication

The results showed the expected transmission speeds in both half-duplex/full-duplex modes.

Link aggregation

Switching was achieved within 1 sec. of disconnection time in most. However, disconnection time in line fault detection with 1000BASE-T is longer than with 100BASE-TX. This is due to the physical layer standard for link-down detection (IEEE802.1ab).

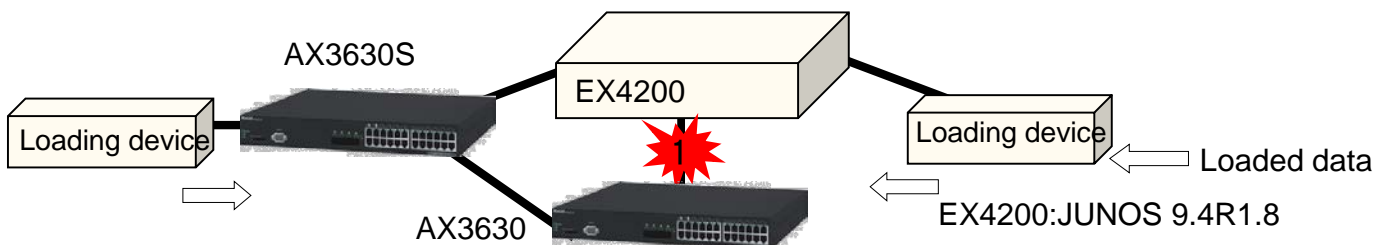
2. STP, RSTP

STP configuration, RSTP configuration

Packets were transmitted without causing a loop and also transmitted after topology change upon line fault occurrence/recovery.

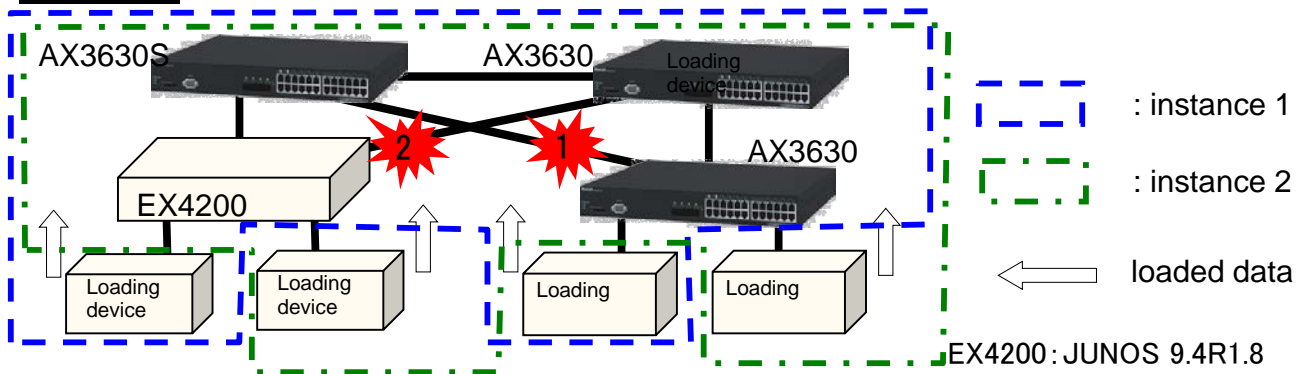
3. MSTP

MSTP configuration

Packets were transmitted without causing a loop. In each instance, topology change was achieved upon line fault occurrence/recovery and communication was established.

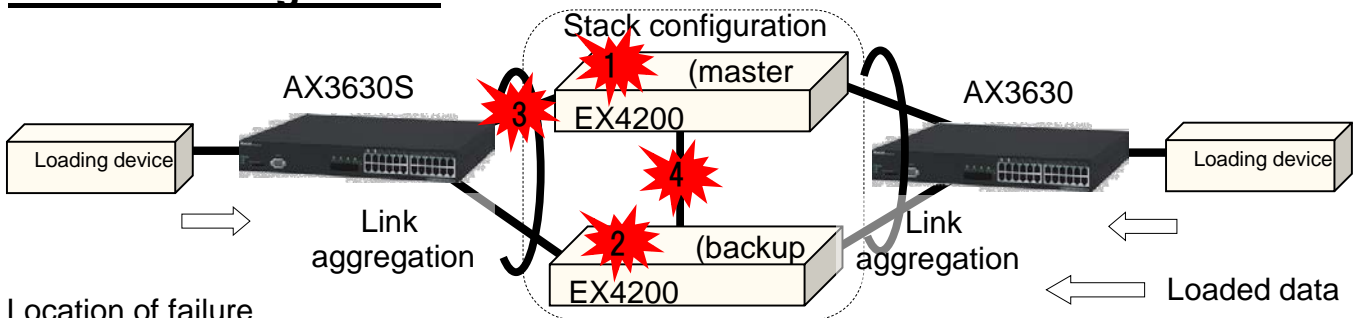
4. Stack configuration

Location of failure

- 1 Stack configuration device (master) : power shut off
- 2 Stack configuration device (backup) : power shut off
- 3 UTP cable : cable disconnected
- 4 Stack cable : one stack cable disconnected
